Guidelines for Detection, Analysis, and Treatment of Materials-Related Distress in Concrete Pavements Volume 3: Case Studies Using the Guidelines

PUBLICATION NO. FHWA-RD-01-165

AUGUST 2002

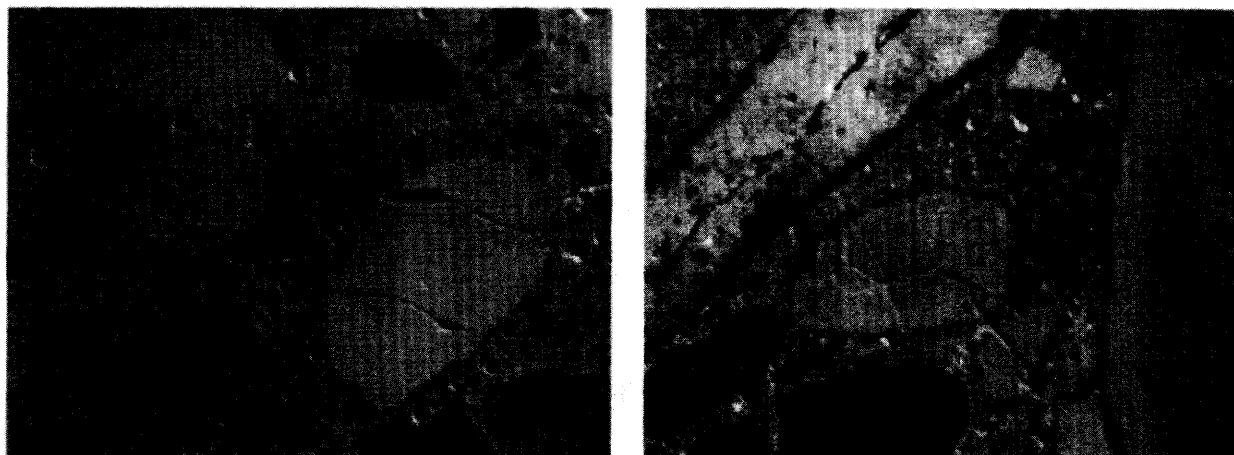
(a) Siltstone aggregate

Figure 3-6. Stereo optical micrographs of typical cracking pattern associated with porous siltstone aggregate SD-090-019.

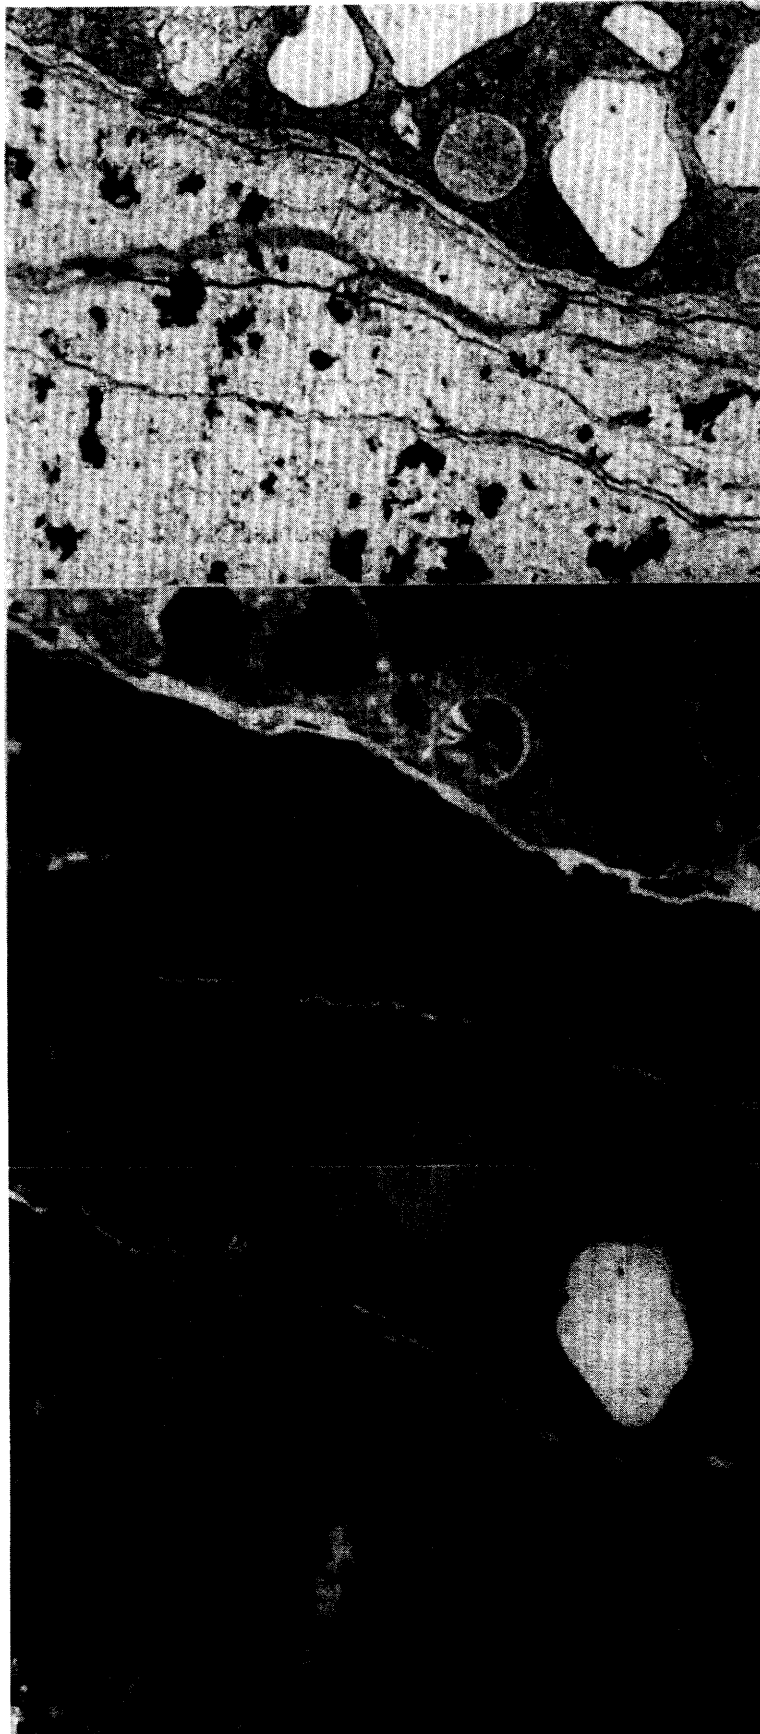
Figure 3-12. Core SD-090-019-001B, thin-section micrographs of same rhyolite aggregate that was stained with sodium cobaltinitrite ASR stain as shown in figure 3-9 (b). From top to bottom: transmitted plane polarized light, epifluorescent mode, and transmitted cross polarized light. Ettringite can be seen filling the entrained air void, ASR gel can be seen in the crack within the aggregate, and hydrocalumite can be seen in the crack along the contact between the aggregate and the cement paste. This same area was analyzed with the SEM to collect quantitative chemical information about the gel, ettringite, and hydrocalumite.

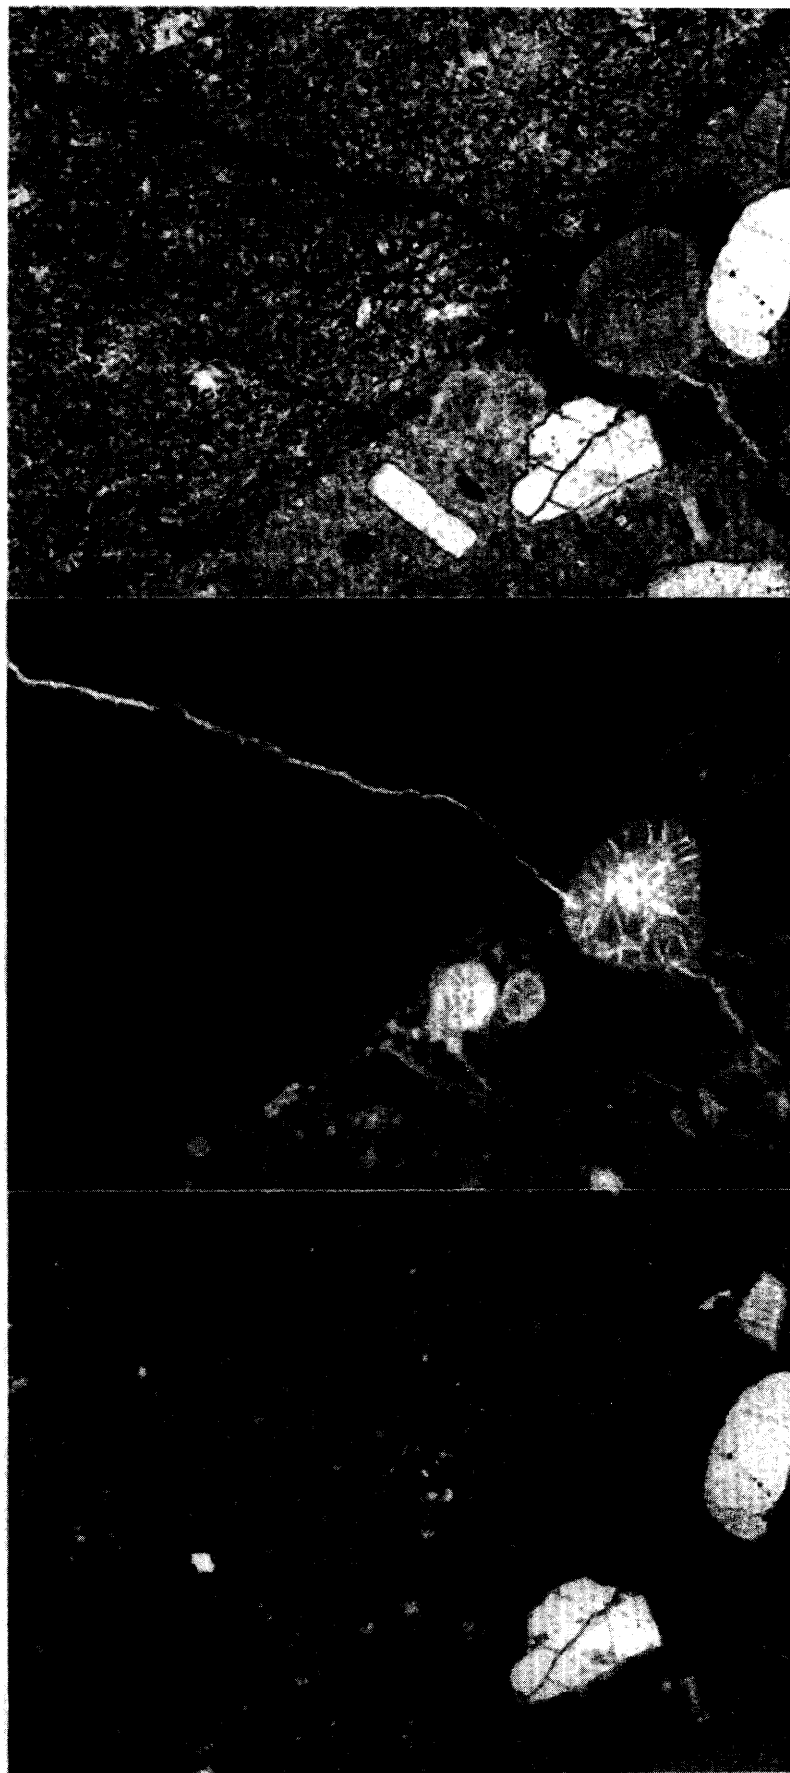
Figure 3-13. Core SD-090-019-001B, thin-section micrographs of same volcanic aggregate that was stained with sodium cobaltinitrite ASR stain as shown in figure 3-8 (c).

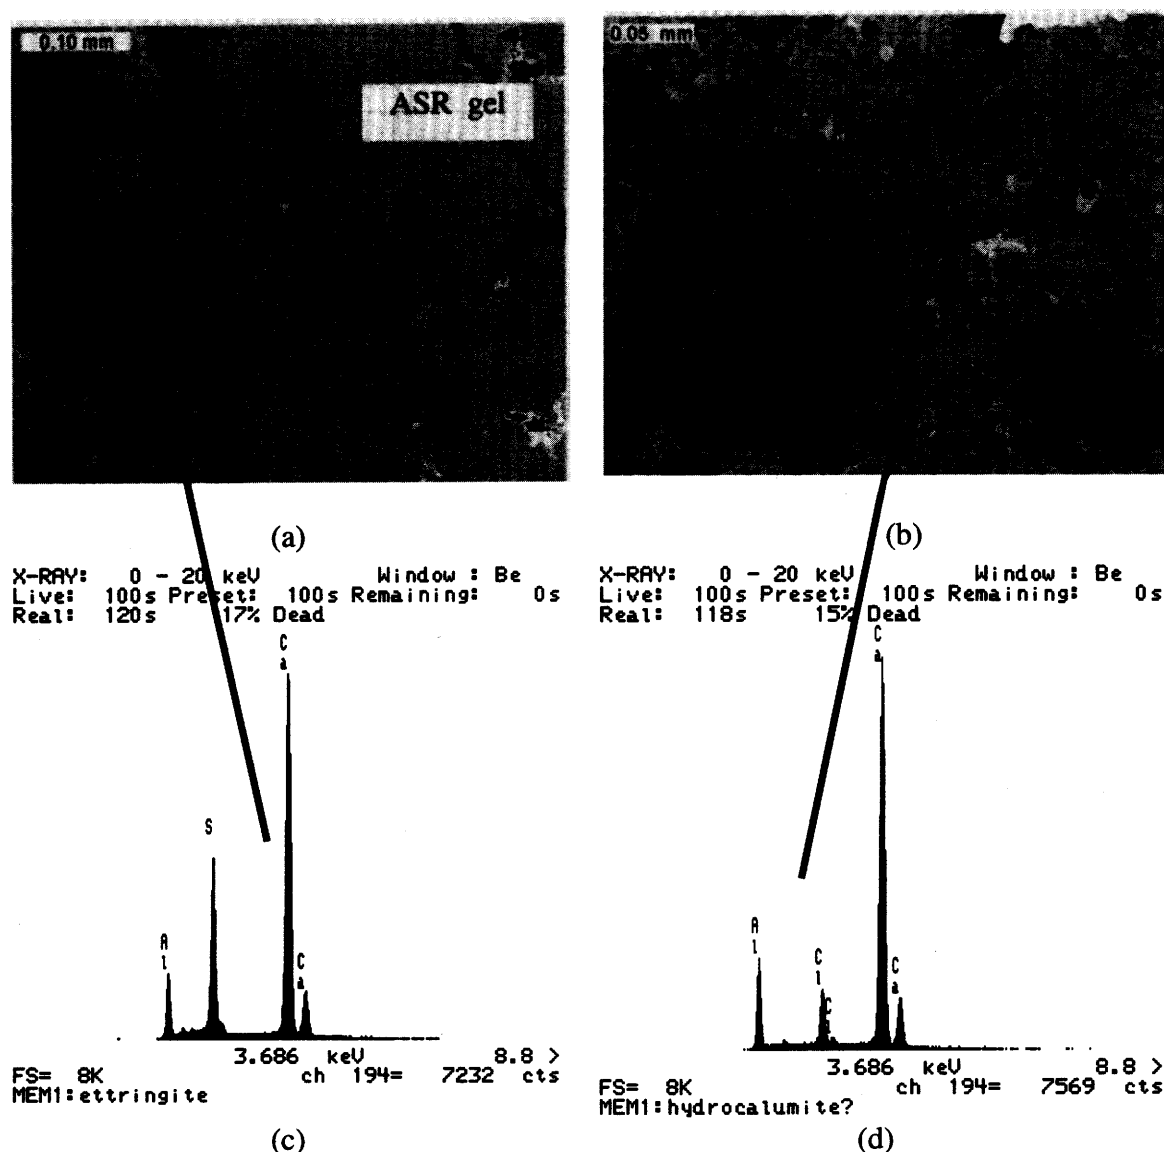
Figure 3-14. Ettringite (a) and hydrocalumite (b) infilling in void and crack, respectively. Example spectra from each phase are shown in (c) and (d), respectively.

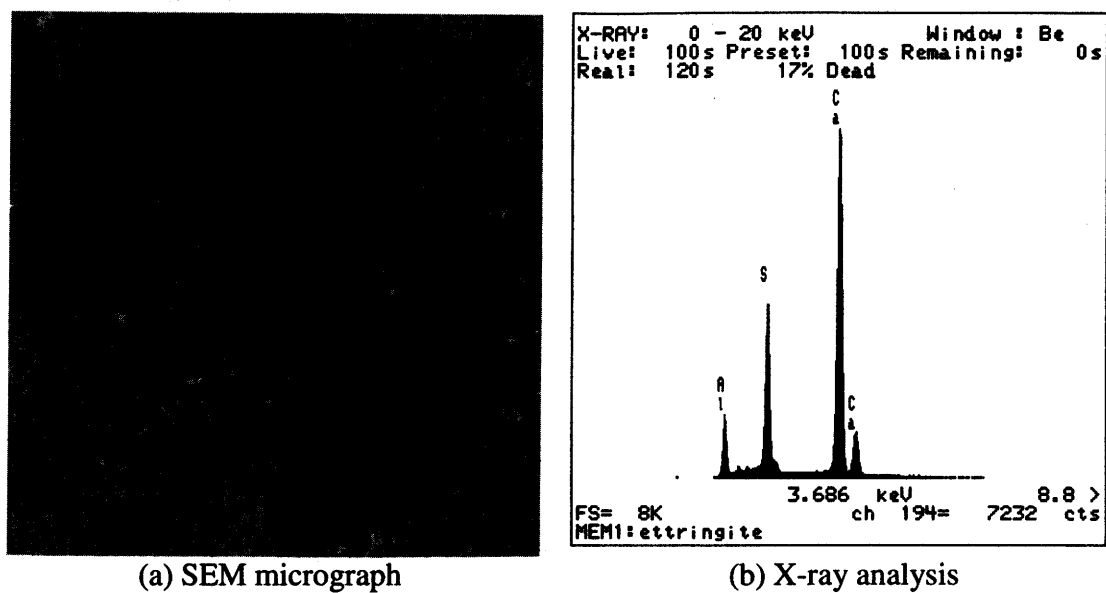
Figure 3-39. Typical SEM micrograph and x-ray analysis for ettringite infilling air void.

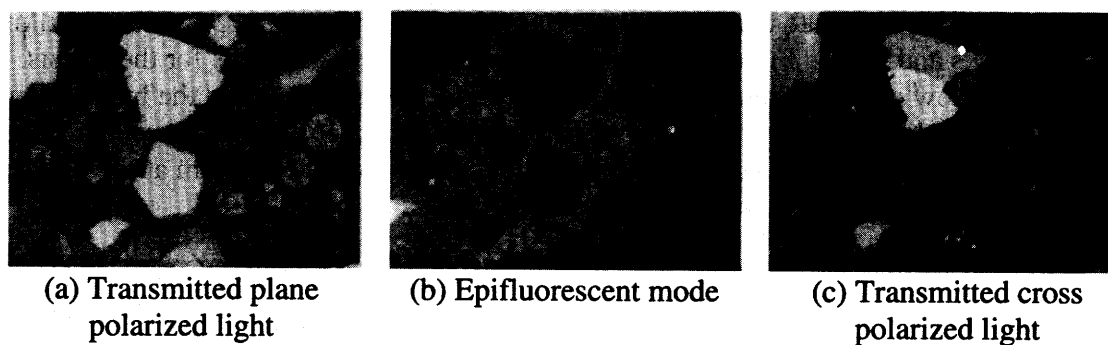
Figure 3-50. Petrographic micrographs from spall obtained from NC-440-015 showing ettringite filled entrained air voids. Ettringite growths are unusually dense.

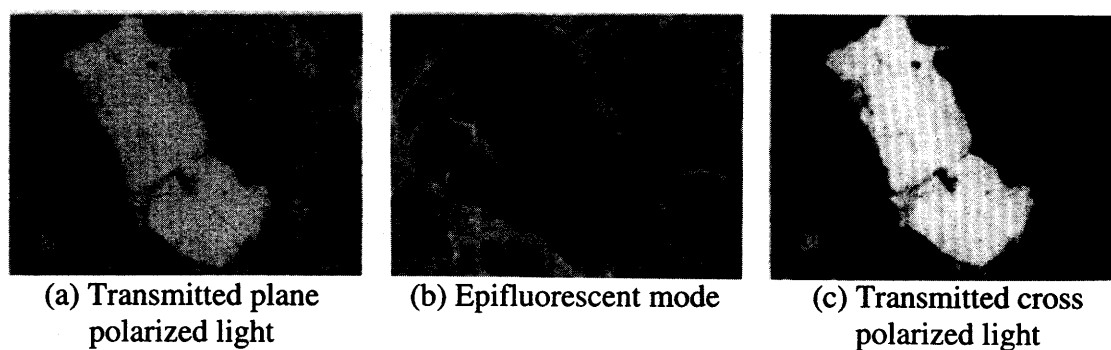
Figure 3-51. Petrographic micrograph of a tan to red coating observed on some of the fine aggregates that appears to undergo ASR from spall obtained from NC-440-015.

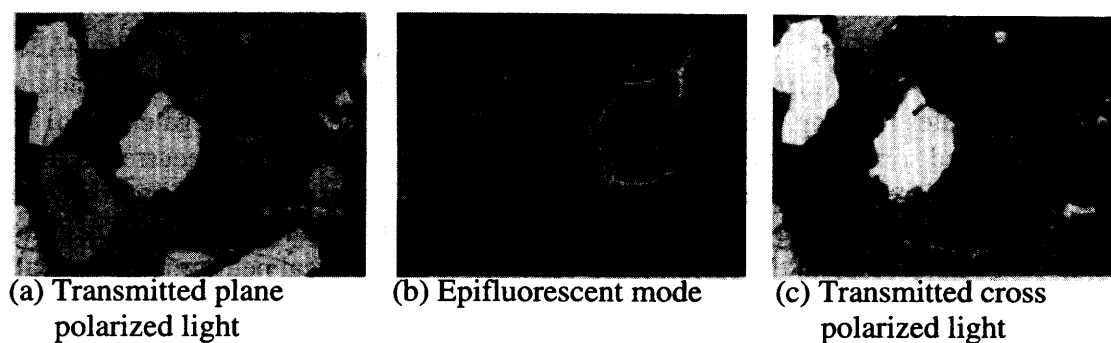
Figure 3-52. Petrographic micrograph of ettringite and “ASR gel blob” from spall obtained from NC-440-015. The term ASR gel is misleading in this example, since the reaction product is slightly birefringent and, therefore, crystalline.

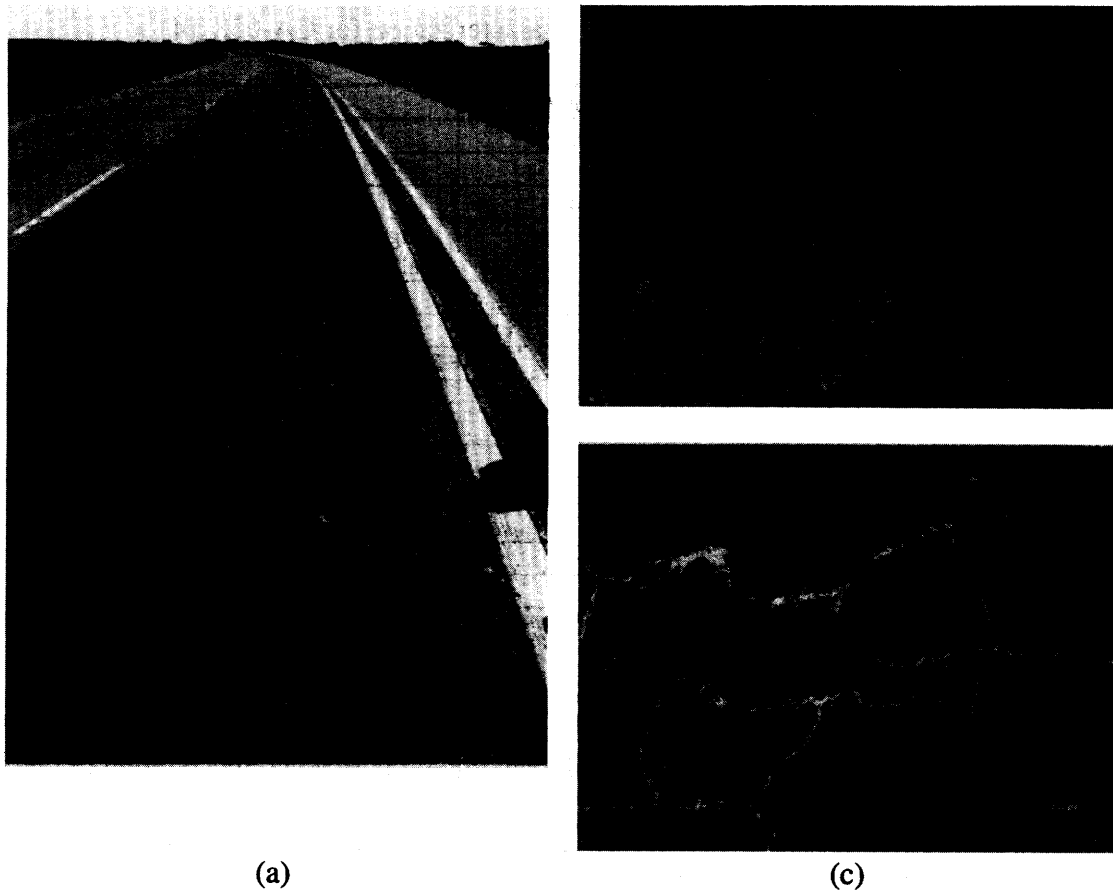
Figure 3-63. Typical conditions at CA-058-141.

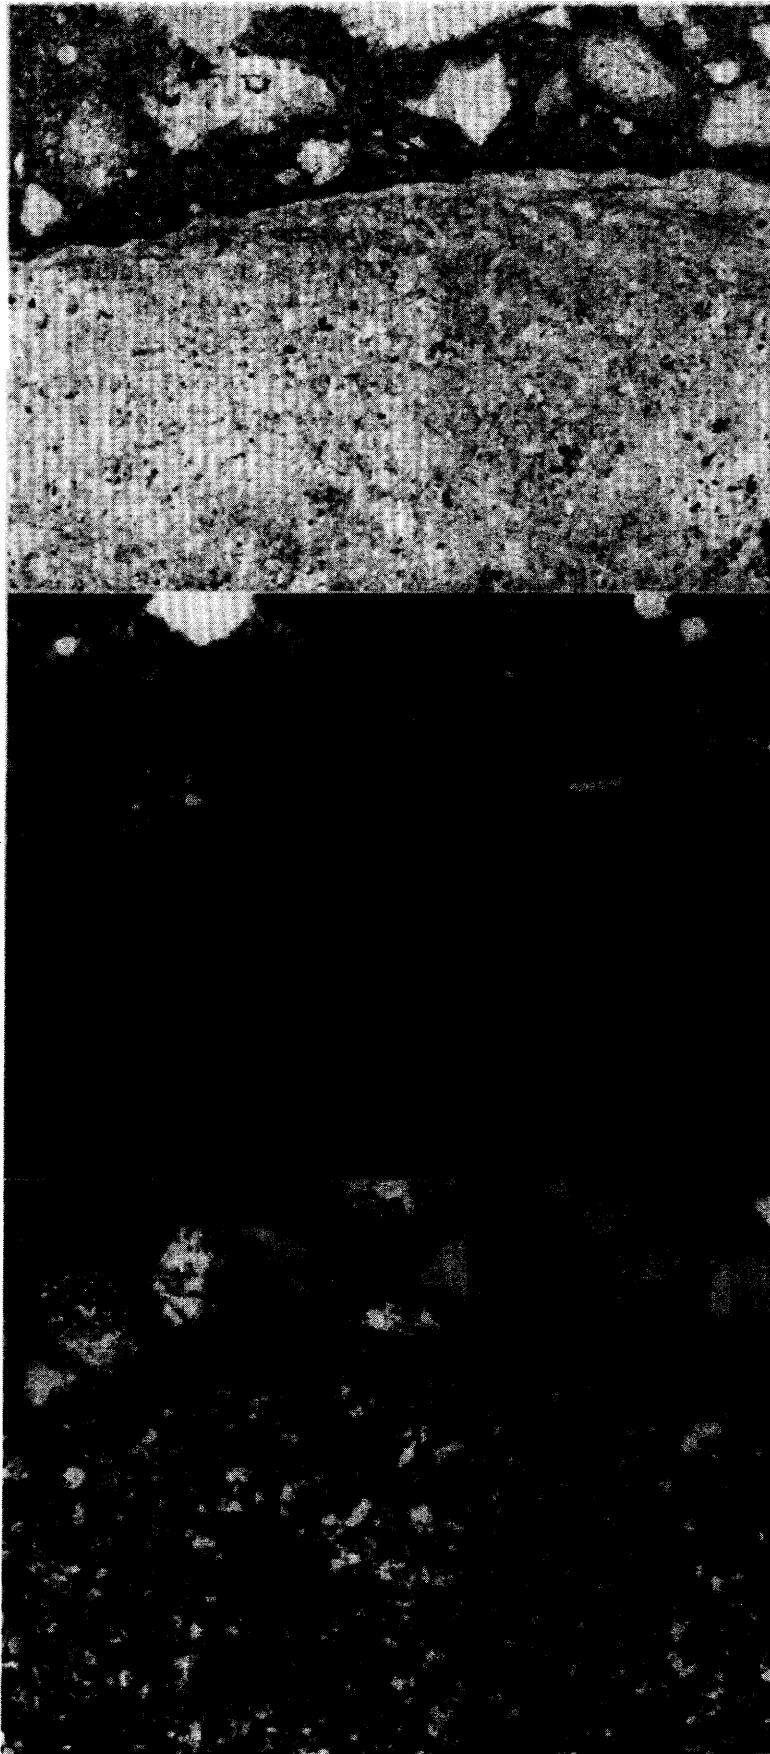
Figure 3-66. Petrographic micrograph of core CA-058-141-001E, thin-section micrographs of ASR gel deposit in crack along felsic volcanic aggregate. The same deposit was analyzed with the SEM to collect quantitative chemical information about the gel. From top to bottom: transmitted plane polarized light, epifluorescent mode, and transmitted cross polarized light (magnified 48x).

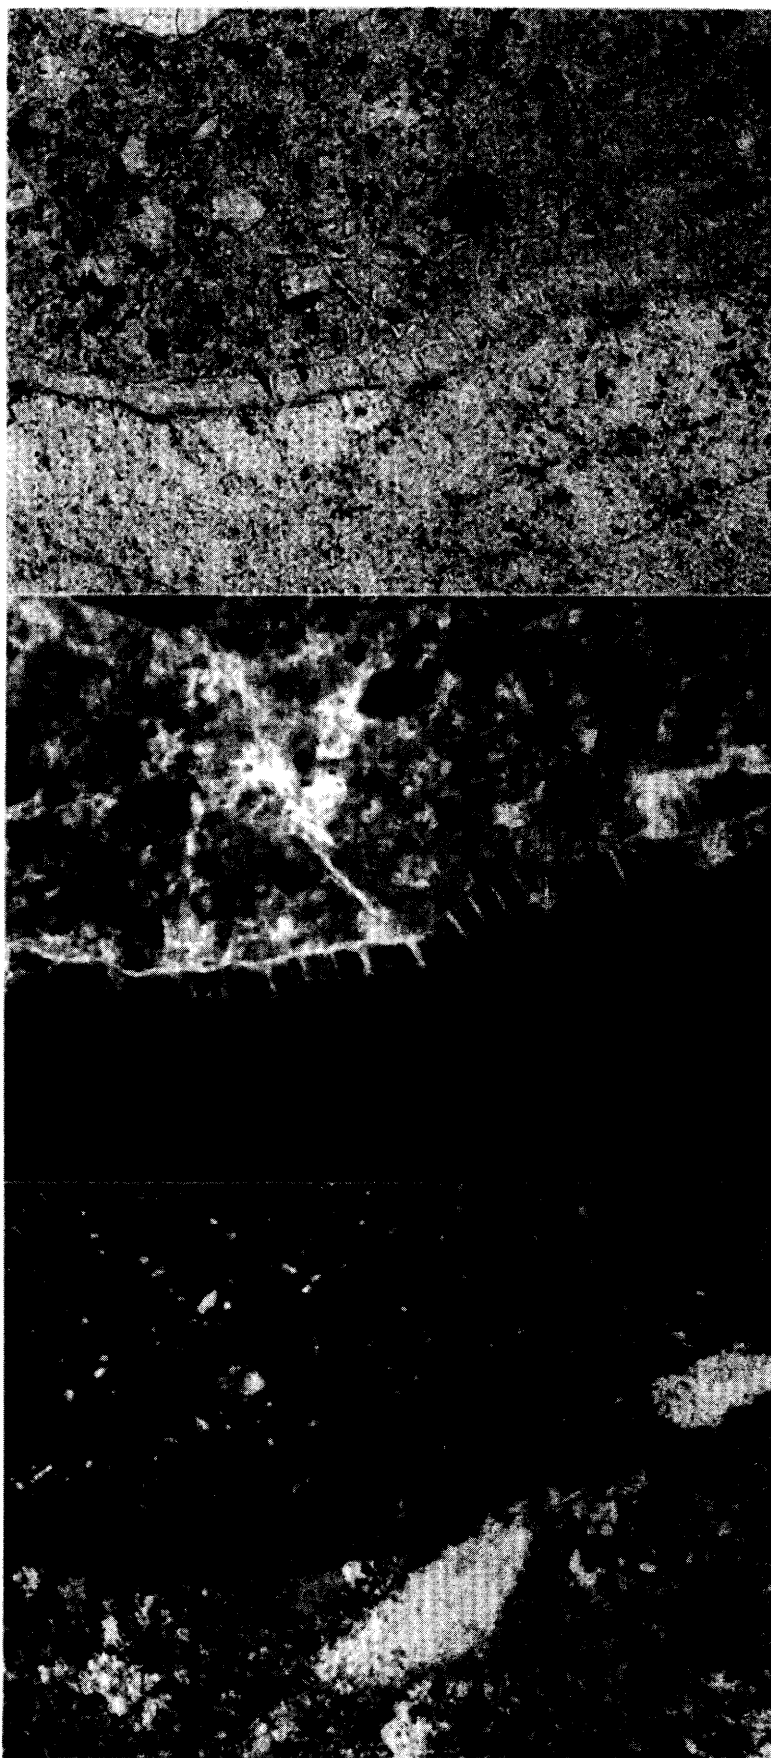
Figure 3-67. Petrographic micrograph of core CA-058-141-001E, thin-section micrographs of ettringite filled crack along contact between coarse aggregate and cement paste. From top to bottom: transmitted plane polarized light, epifluorescent mode, and transmitted cross polarized light (magnified 188x).

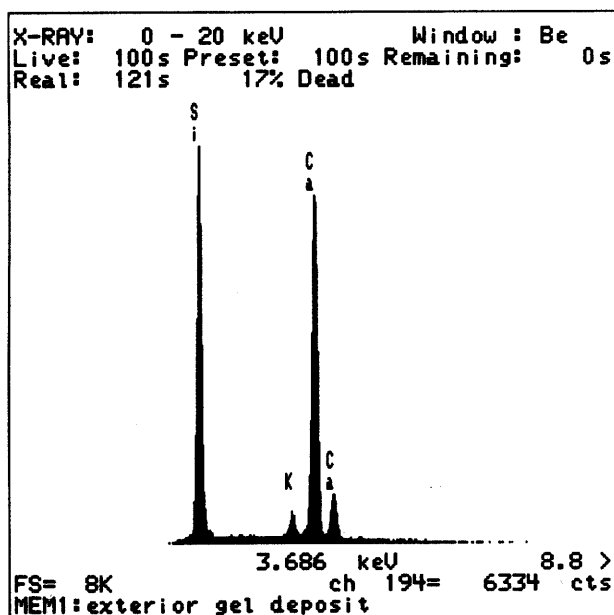
(a) Typical spectrum from ASR gel adjacent to volcanic aggregate pictured in (b).

(b) BSE image of ettringite filling a crack along the contact between a coarse aggregate and the cement paste.

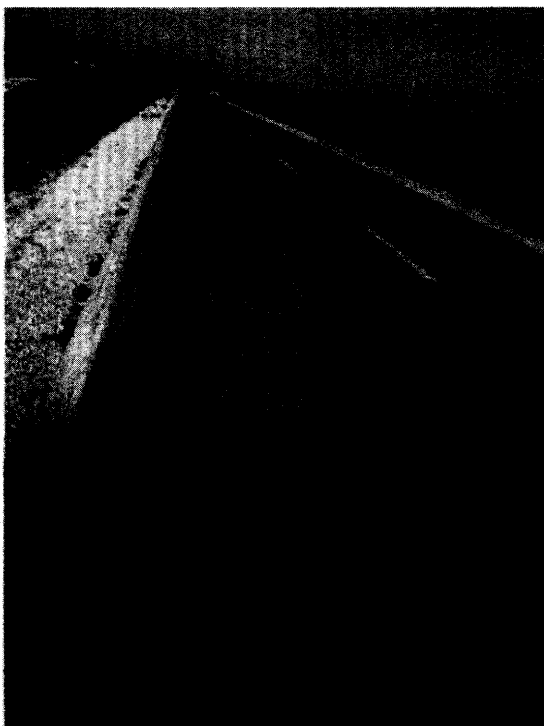
(a) Staining along longitudinal cracks

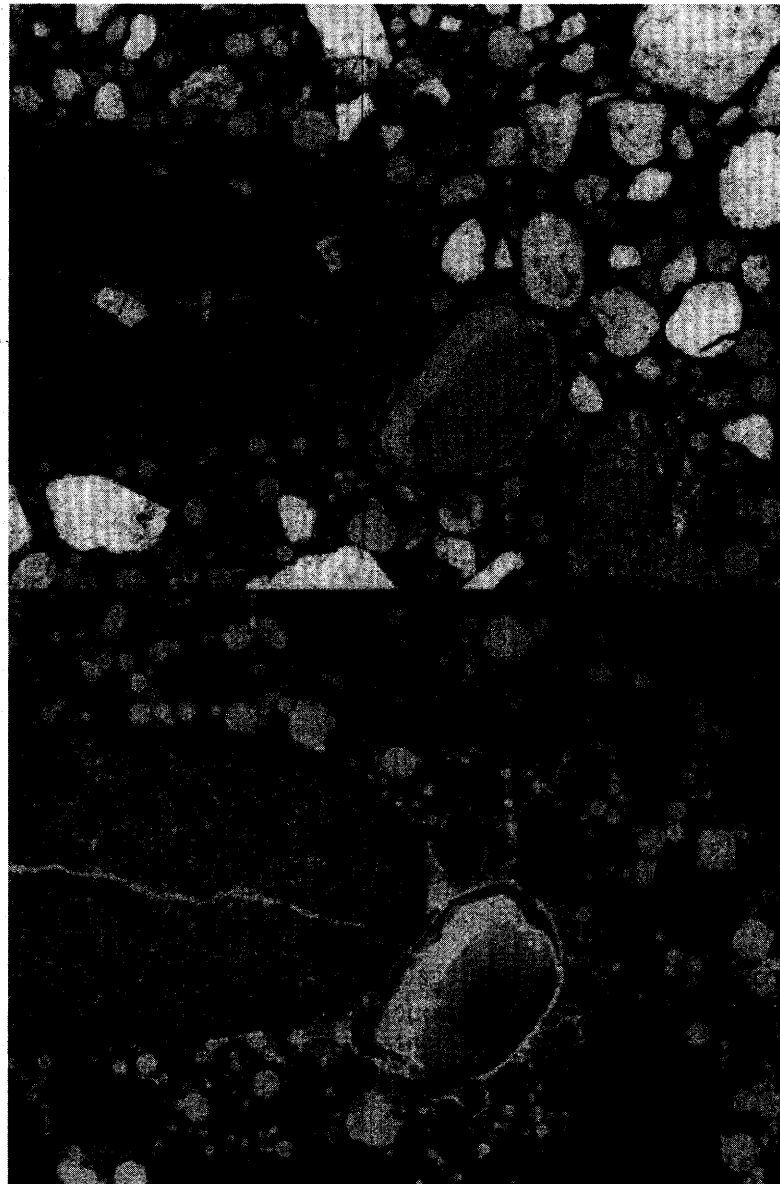
Figure 3-85. Reactive fine aggregate particle with alkali-silica gel filled air voids as viewed in thin section. Top image is transmitted plane polarized light, bottom image is in epifluorescent mode, magnified 20x.
